**TRANSPORTATION SCIENCES  
CRASH DATA RESEARCH CENTER**

Veridian Engineering  
Calspan Operations  
Buffalo, New York 14225

**CALSPAN ON-SITE AIR BAG RELATED CHILD FATALITY INVESTIGATION  
CALSPAN CASE NO. CA96-010  
VEHICLE - 1996 DODGE CARAVAN SE  
LOCATION - TENNESSEE  
CRASH DATE - 1996**

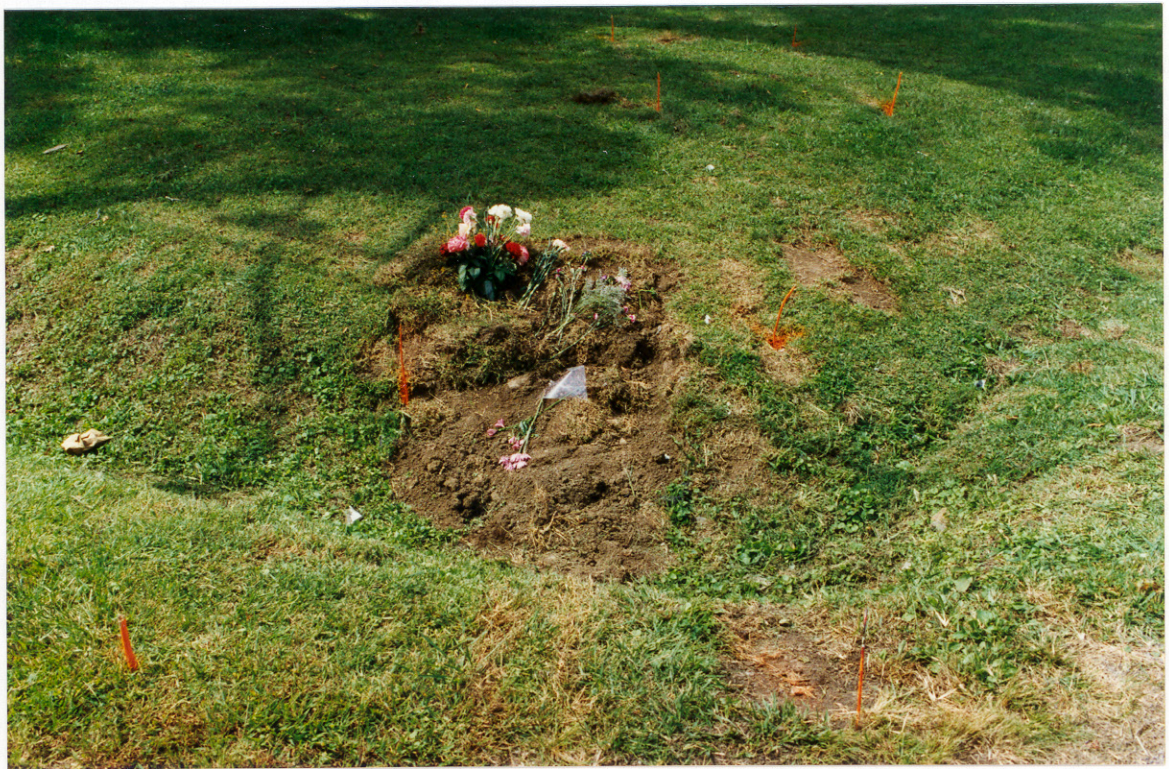
12. View of the embankment impacted by the front of the Dodge.

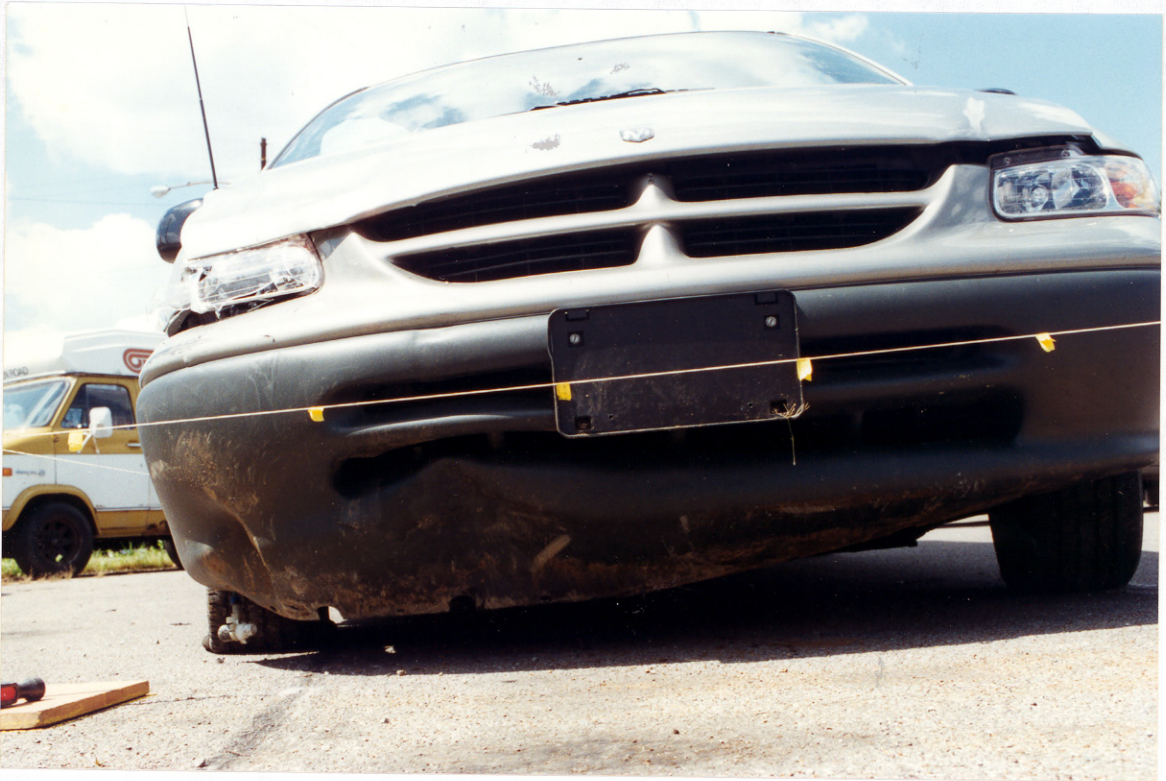
34. Front view of the damage to the lower surface of the bumper fascia.

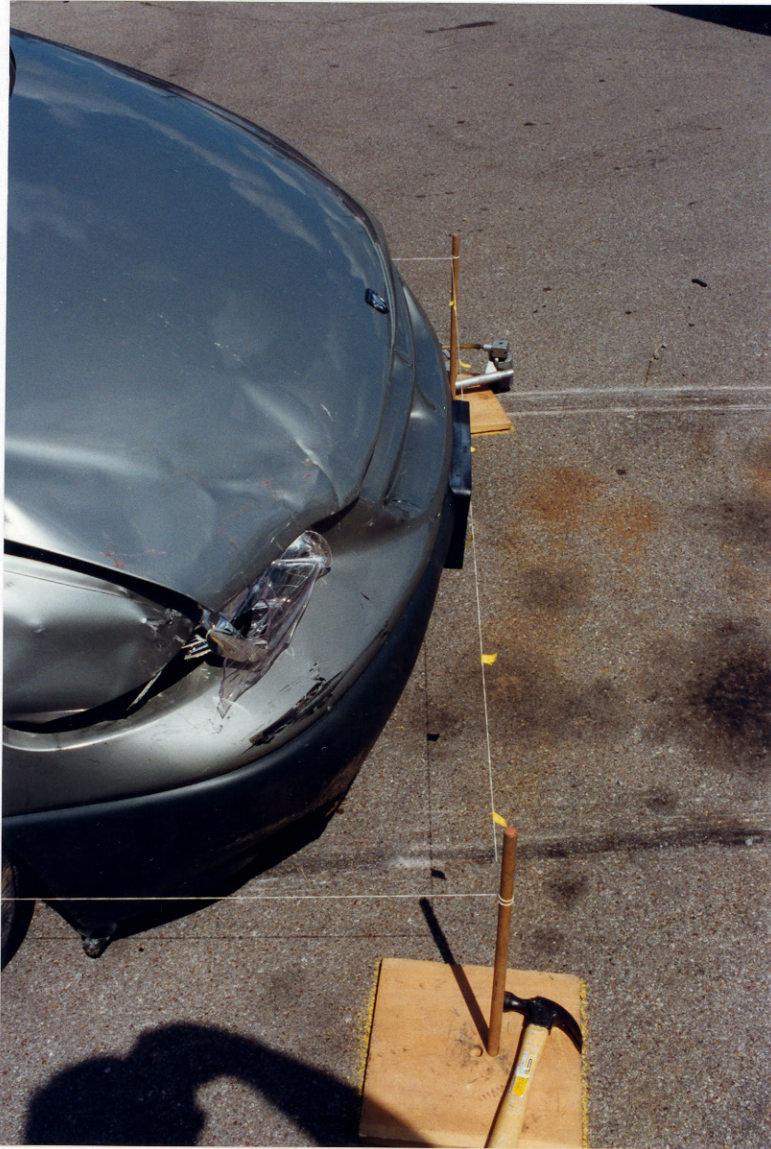
47. Right lateral view of the damage to the front of the Dodge Caravan.

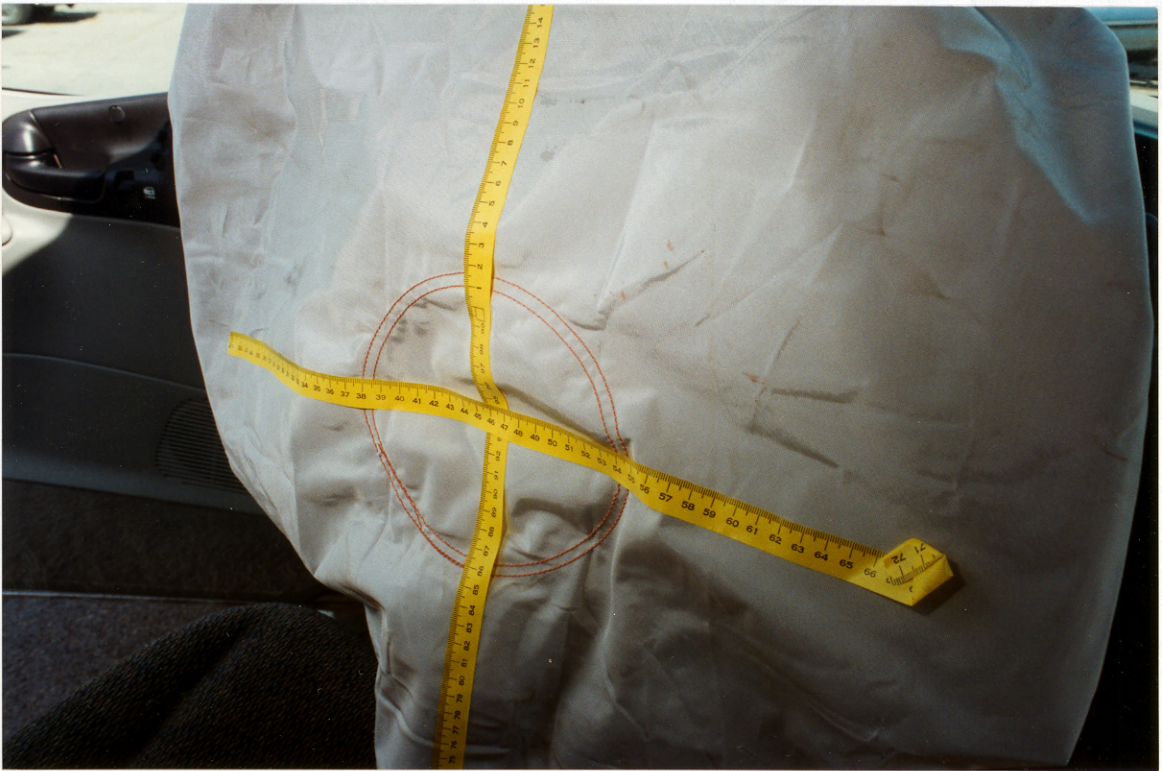
53. Close-up view of blood spatters on the lower left quadrant of the air bag.

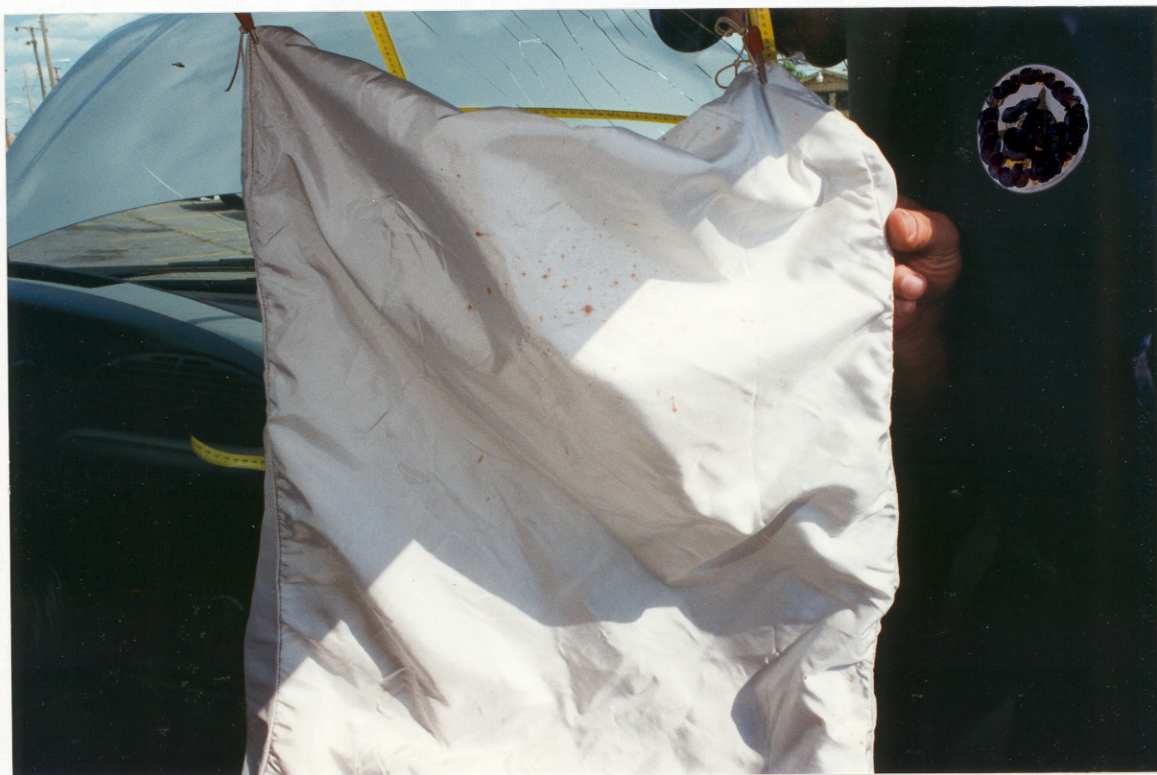
Three blood spatter patterns were noted to the front right air bag. The first spatter was located 17.8-38.1 cm (7.0-15.0 in) right of the left side of the air bag and 7.6-20.3 cm (3.0-

8.0 in) down from the top of the bag (refer to Photograph No. 70). The second blood spatter was noted 30.5-38.1 cm (12.0-15.0 in) below the top of the bag and 0.0-5.1 cm (0.0-2.0 in) inboard of the right side of the bag (refer to Photograph No. 73). A third blood spatter was located 54.6-58.4 cm (21.5-23.0 in) below the top of the bag and 14.0-21.6 cm (5.5-8.5 in) inboard of the right side (refer to Photograph No. 72). A probable body fluid/material (tissue or nasal expulsion) transfer of 12.7 cm (5.0 in) in length was located on the right side of the passenger side air bag, centered between the side seams and 7.6 cm (3.0 in) above the lower seam. Gray vinyl transfers were present at the bottom right sector of the bag 13.3-5.1 cm (5.15-2.0 in) up from the bottom seam and 7.0-17.8 cm (2.75-7.0 in) left of the right seam (refer to Photograph No. 74-75). These resulted from bag expansion within the module assembly.

70. View of blood spatters on the face of the air bag at the 12 o'clock position.

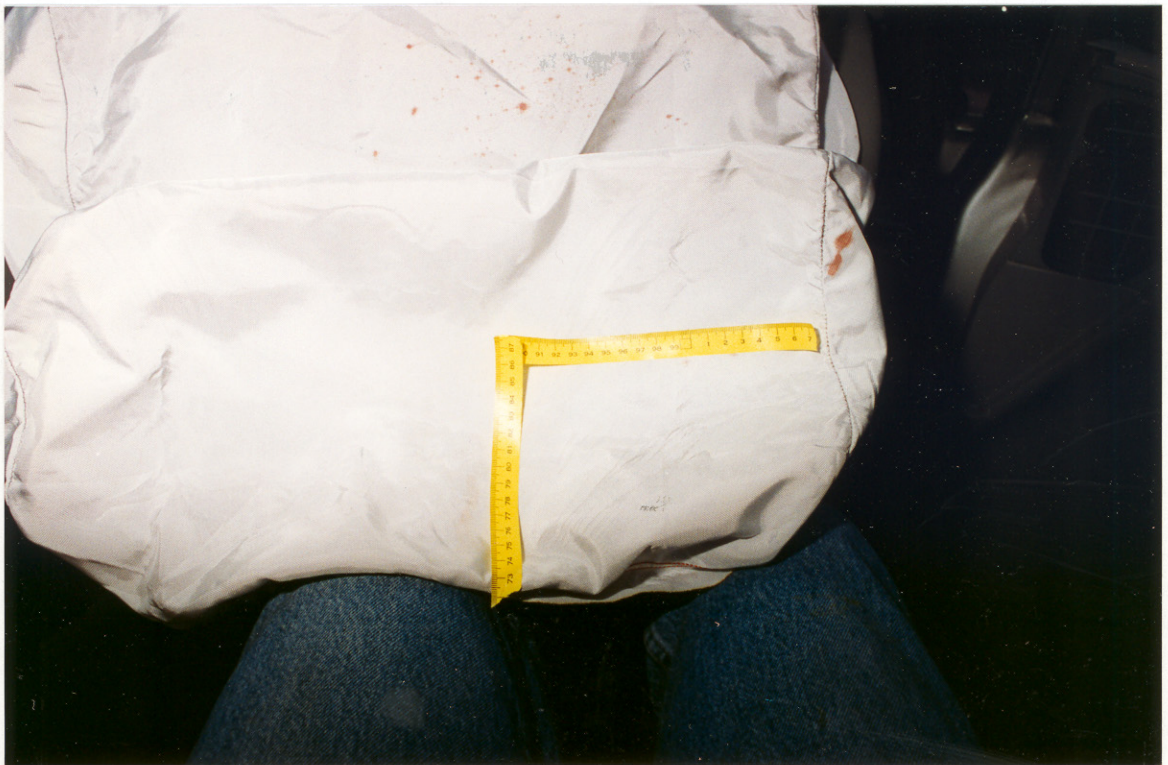
74. View of a gray vinyl transfer on the lower left quadrant of the air bag.

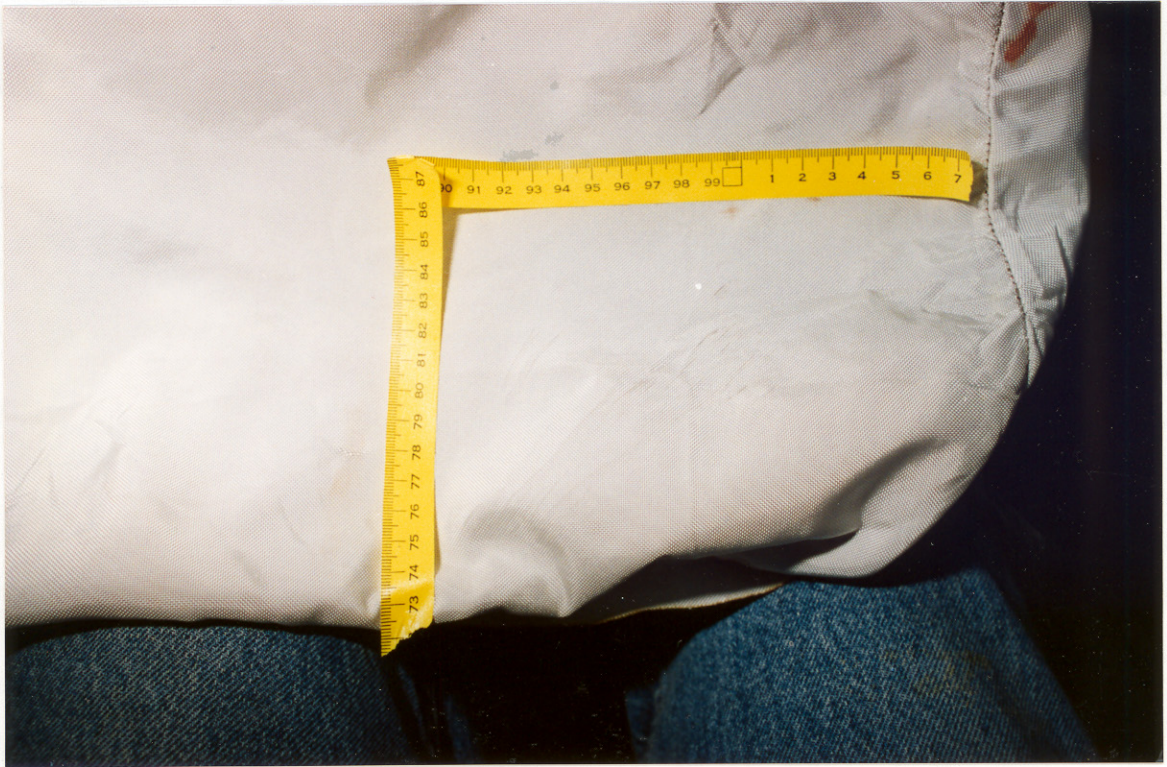
75. Close-up view of the vinyl transfers.

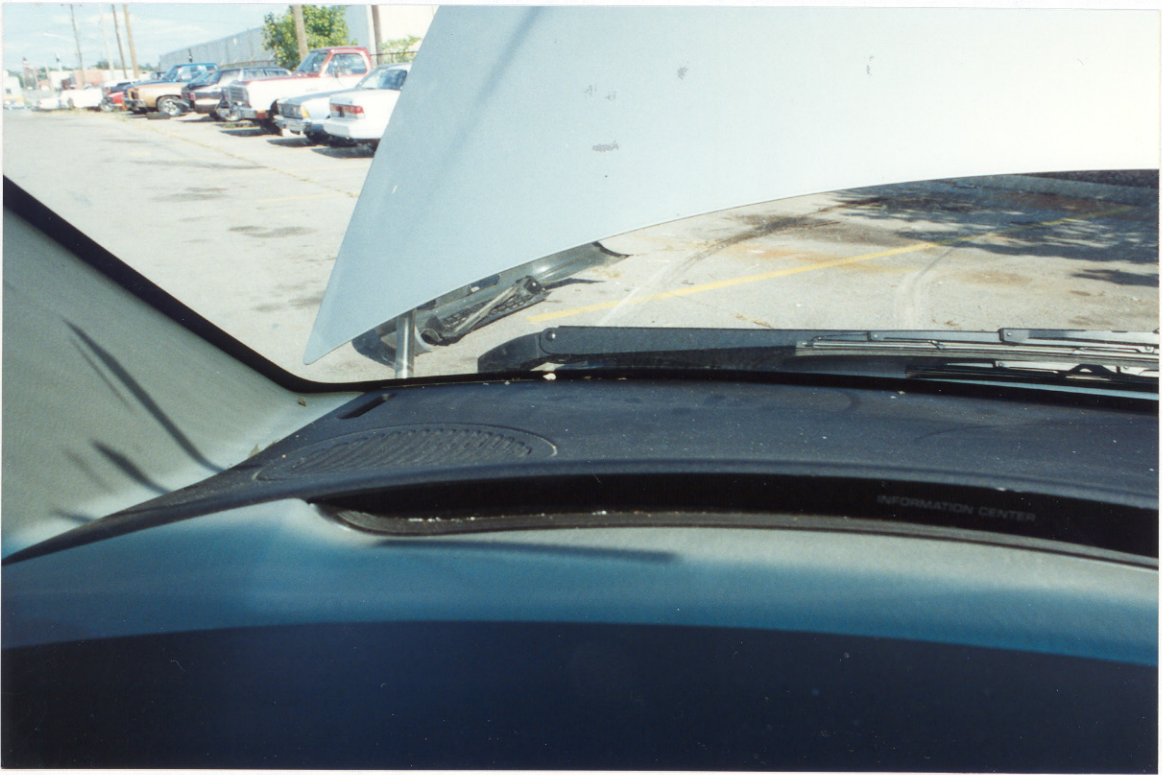
79. View of the avulsed tooth found on the left side of the instrument panel.

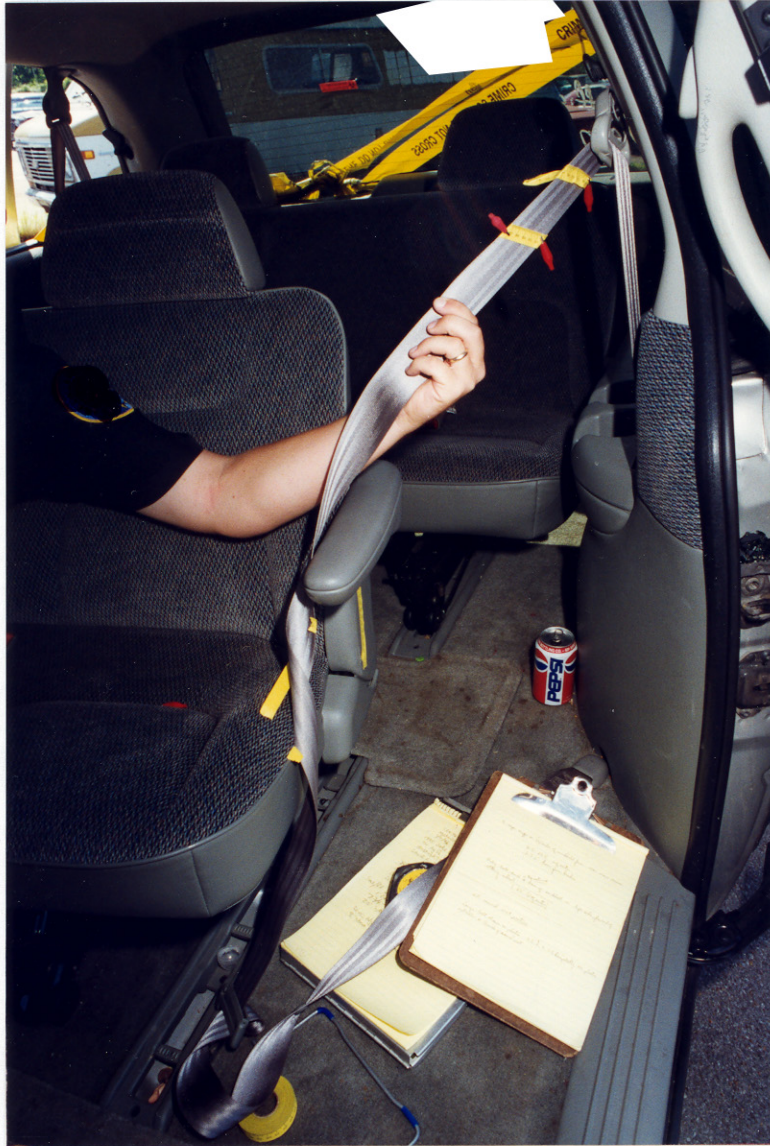
child safety seat on the seat cushion. Abrasions were noted to the shoulder belt webbing and to the plastic extrusion at the seat cushion/seat back juncture. In addition, the loading produced a D-ring transfer to the shoulder belt webbing. This evidence is documented in Photograph Nos. 97-102.

100. View of the restraint webbing for the left side second seat occupant.

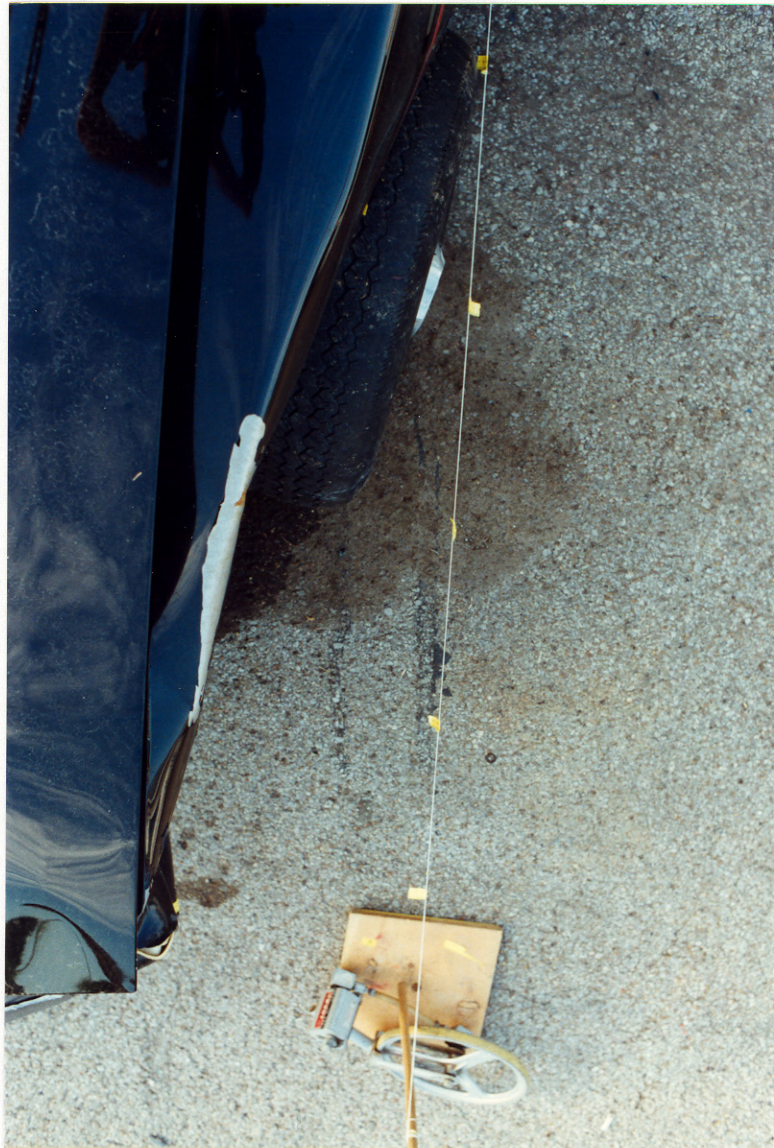
108. Left side view of the direct contact damage.
